Sliammon Creek Hydroelectric Project  
Powell River, BC

Technical Report

**Initial Geotechnical and Dam Assessment**

April 21, 2016

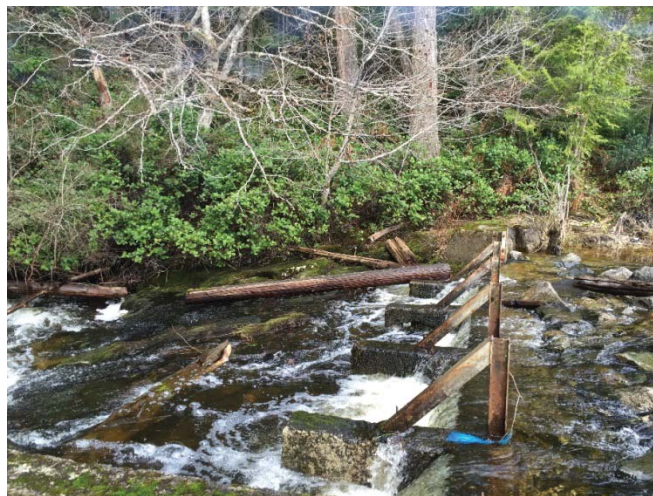
Figure 1 – Bedrock outcrop at the weir dam location

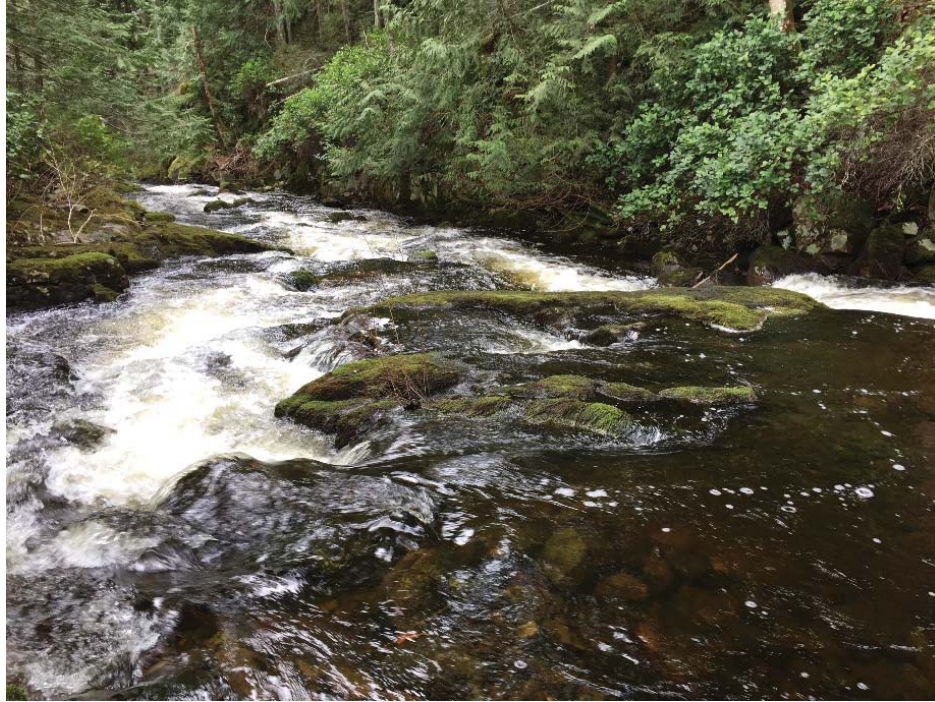
Figure 2 – Bedrock outcrop in the downstream area of the weir dam

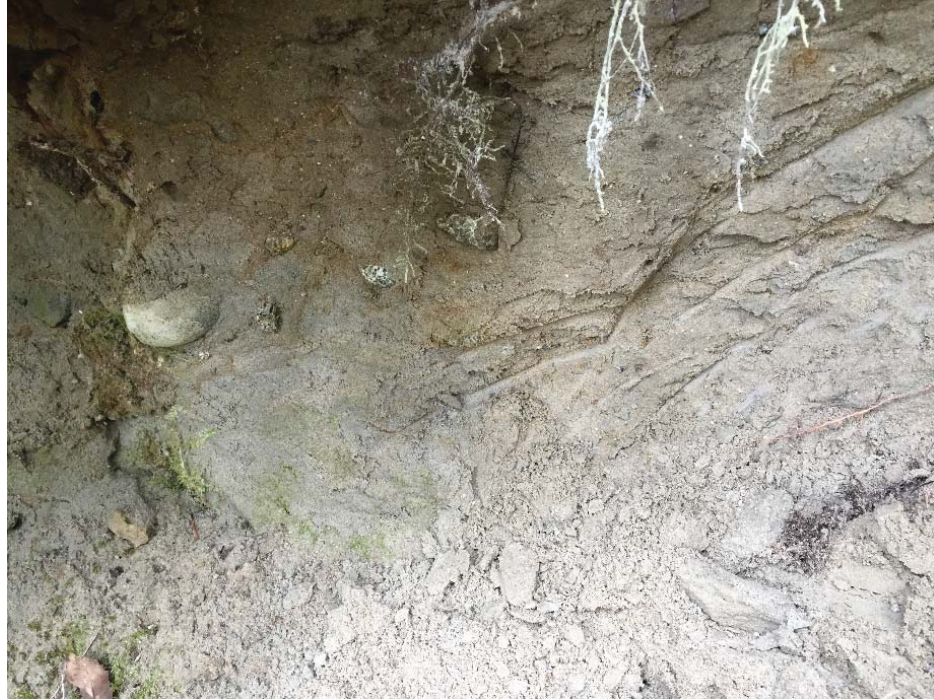
Figure 3 – Glaciofluvial deposits comprising gravelly sand with some rounded cobbles

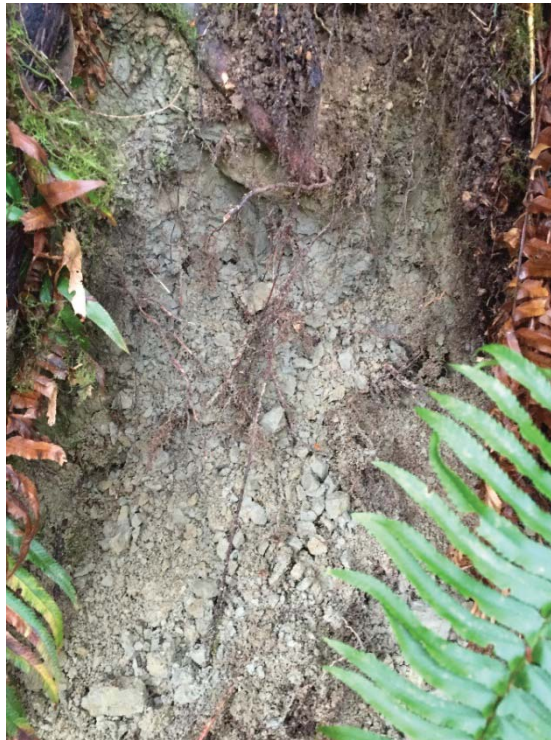
Glacial deposits and till material comprising grey hard silty sand to sandy silt material with some rounded to sub-rounded cobbles and boulders were locally observed on the cut slopes along the forestry access road to Sliammon Lake that are covered by a thin layer of colluvial material.

Figure 4 – Glacial till material observed along the forestry access road to the dam

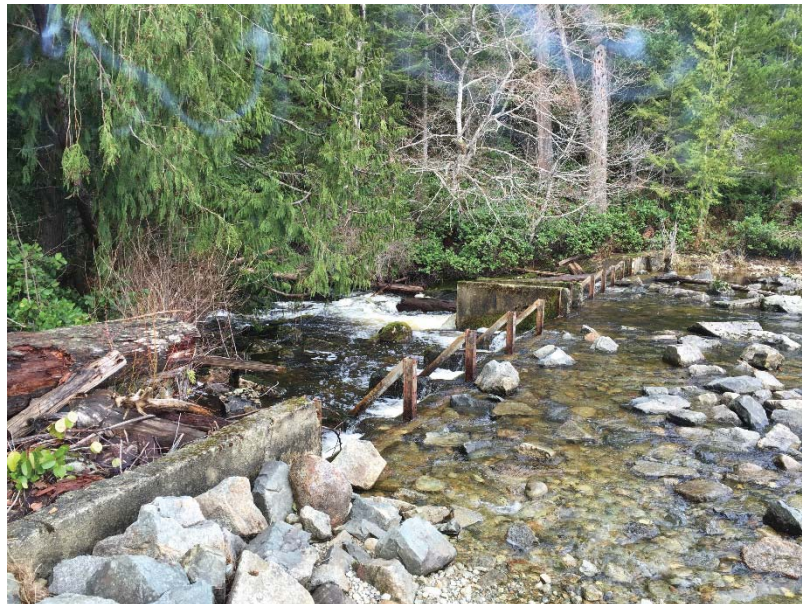
Bedrock outcrop was observed on the right and left abutments of the dam up to about 1 m above the lake level, then covered by fluvial material and colluvial materials on upper slope area. Both dam abutments have a gentle slope with %15-40 and low terrain hazard but right abutment slopes will get steeper in downstream area of the dam. The upstream area of the dam axis is covered by rockfill and riprap material in cobbles to boulder sizes as shown in Figure 6.

Figure 6 – Upstream area of the weir dam

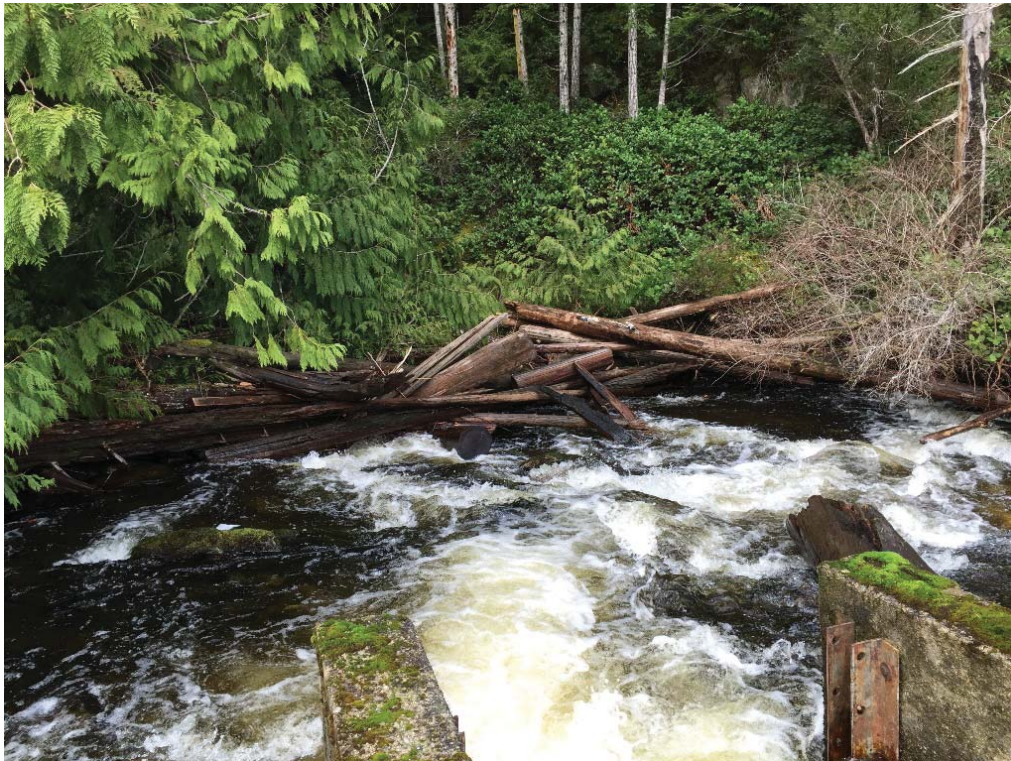
Debris material and jammed logs were observed at downstream of the weir dam and on both right and left banks of the dam as shown in Figure 7. There is evidence of debris flow erosion and impact to the weir dam and its abutments during storm events. The log boom was not installed in the upstream area of the weir to protect the dam structure from debris and log impact during storm events.

Figure 7 – Jammed debris material and logs downstream of the weir dam

- Install a protective log boom on the upstream area of the weir dam location to protect the weir from logs and debris flow impact as shown in Drawing SL-1010 (Appendix A).

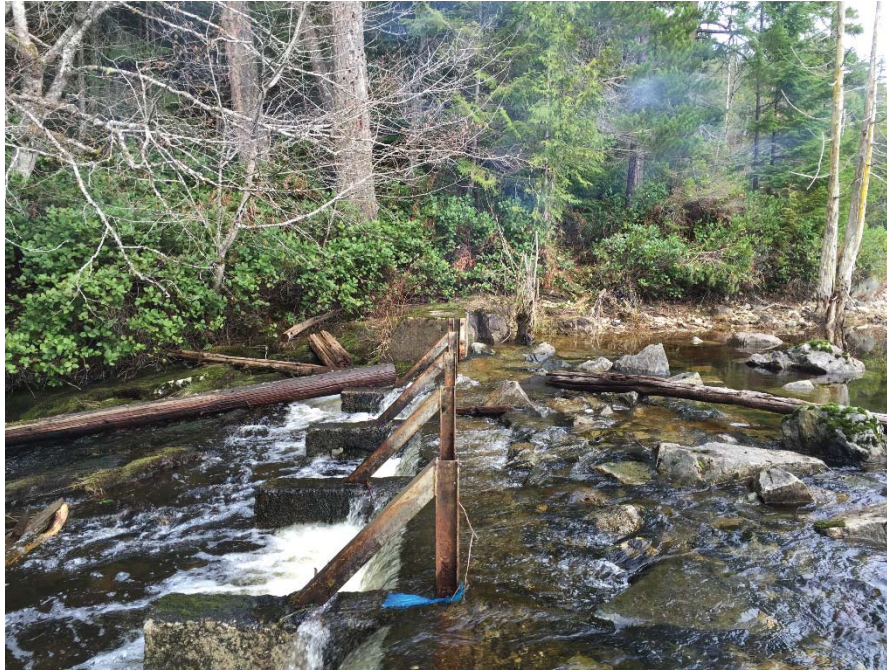
Figure 8 – Debris and erosion evidence on the right abutment of the weir dam

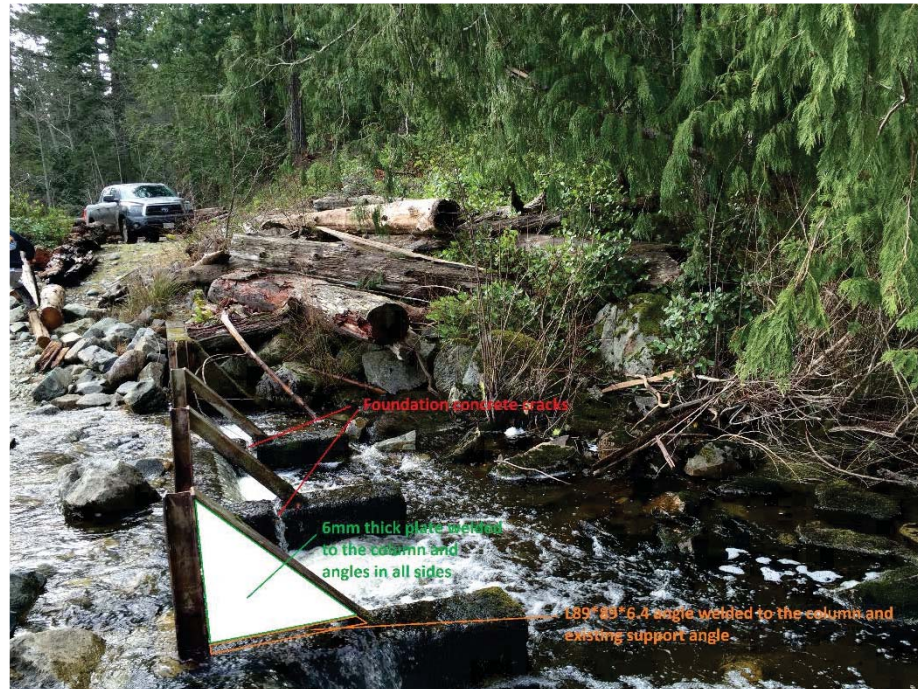
Foundation concrete cracks were observed on downstream areas between the W-shape steel columns and support angles as shown in the Figure 9. These foundation concrete cracks have been generated by upstream forces pushing against the support angles on the downstream side, probably during storm events by impact forces from passing logs and debris over the weir. Given

the presence of these concrete foundation cracks in the downstream area due to debris impact forces, several mitigation measures are recommended to protect and maintain the stability of the weir dam.

Figure 9 – Concrete cracks were observed between W-shape columns and angles supports foundation

- Stabilize the W-shaped weir columns and provide additional reinforcement support with an additional plate welded to each existing W steel column and steel angle support, as shown in the Figure 9.
