SLIAMMON FIRST NATION
MASTER DRAINAGE PLAN
Feasibility Report

David Nairne + Associates Ltd.

July 2008

Feasibility Report

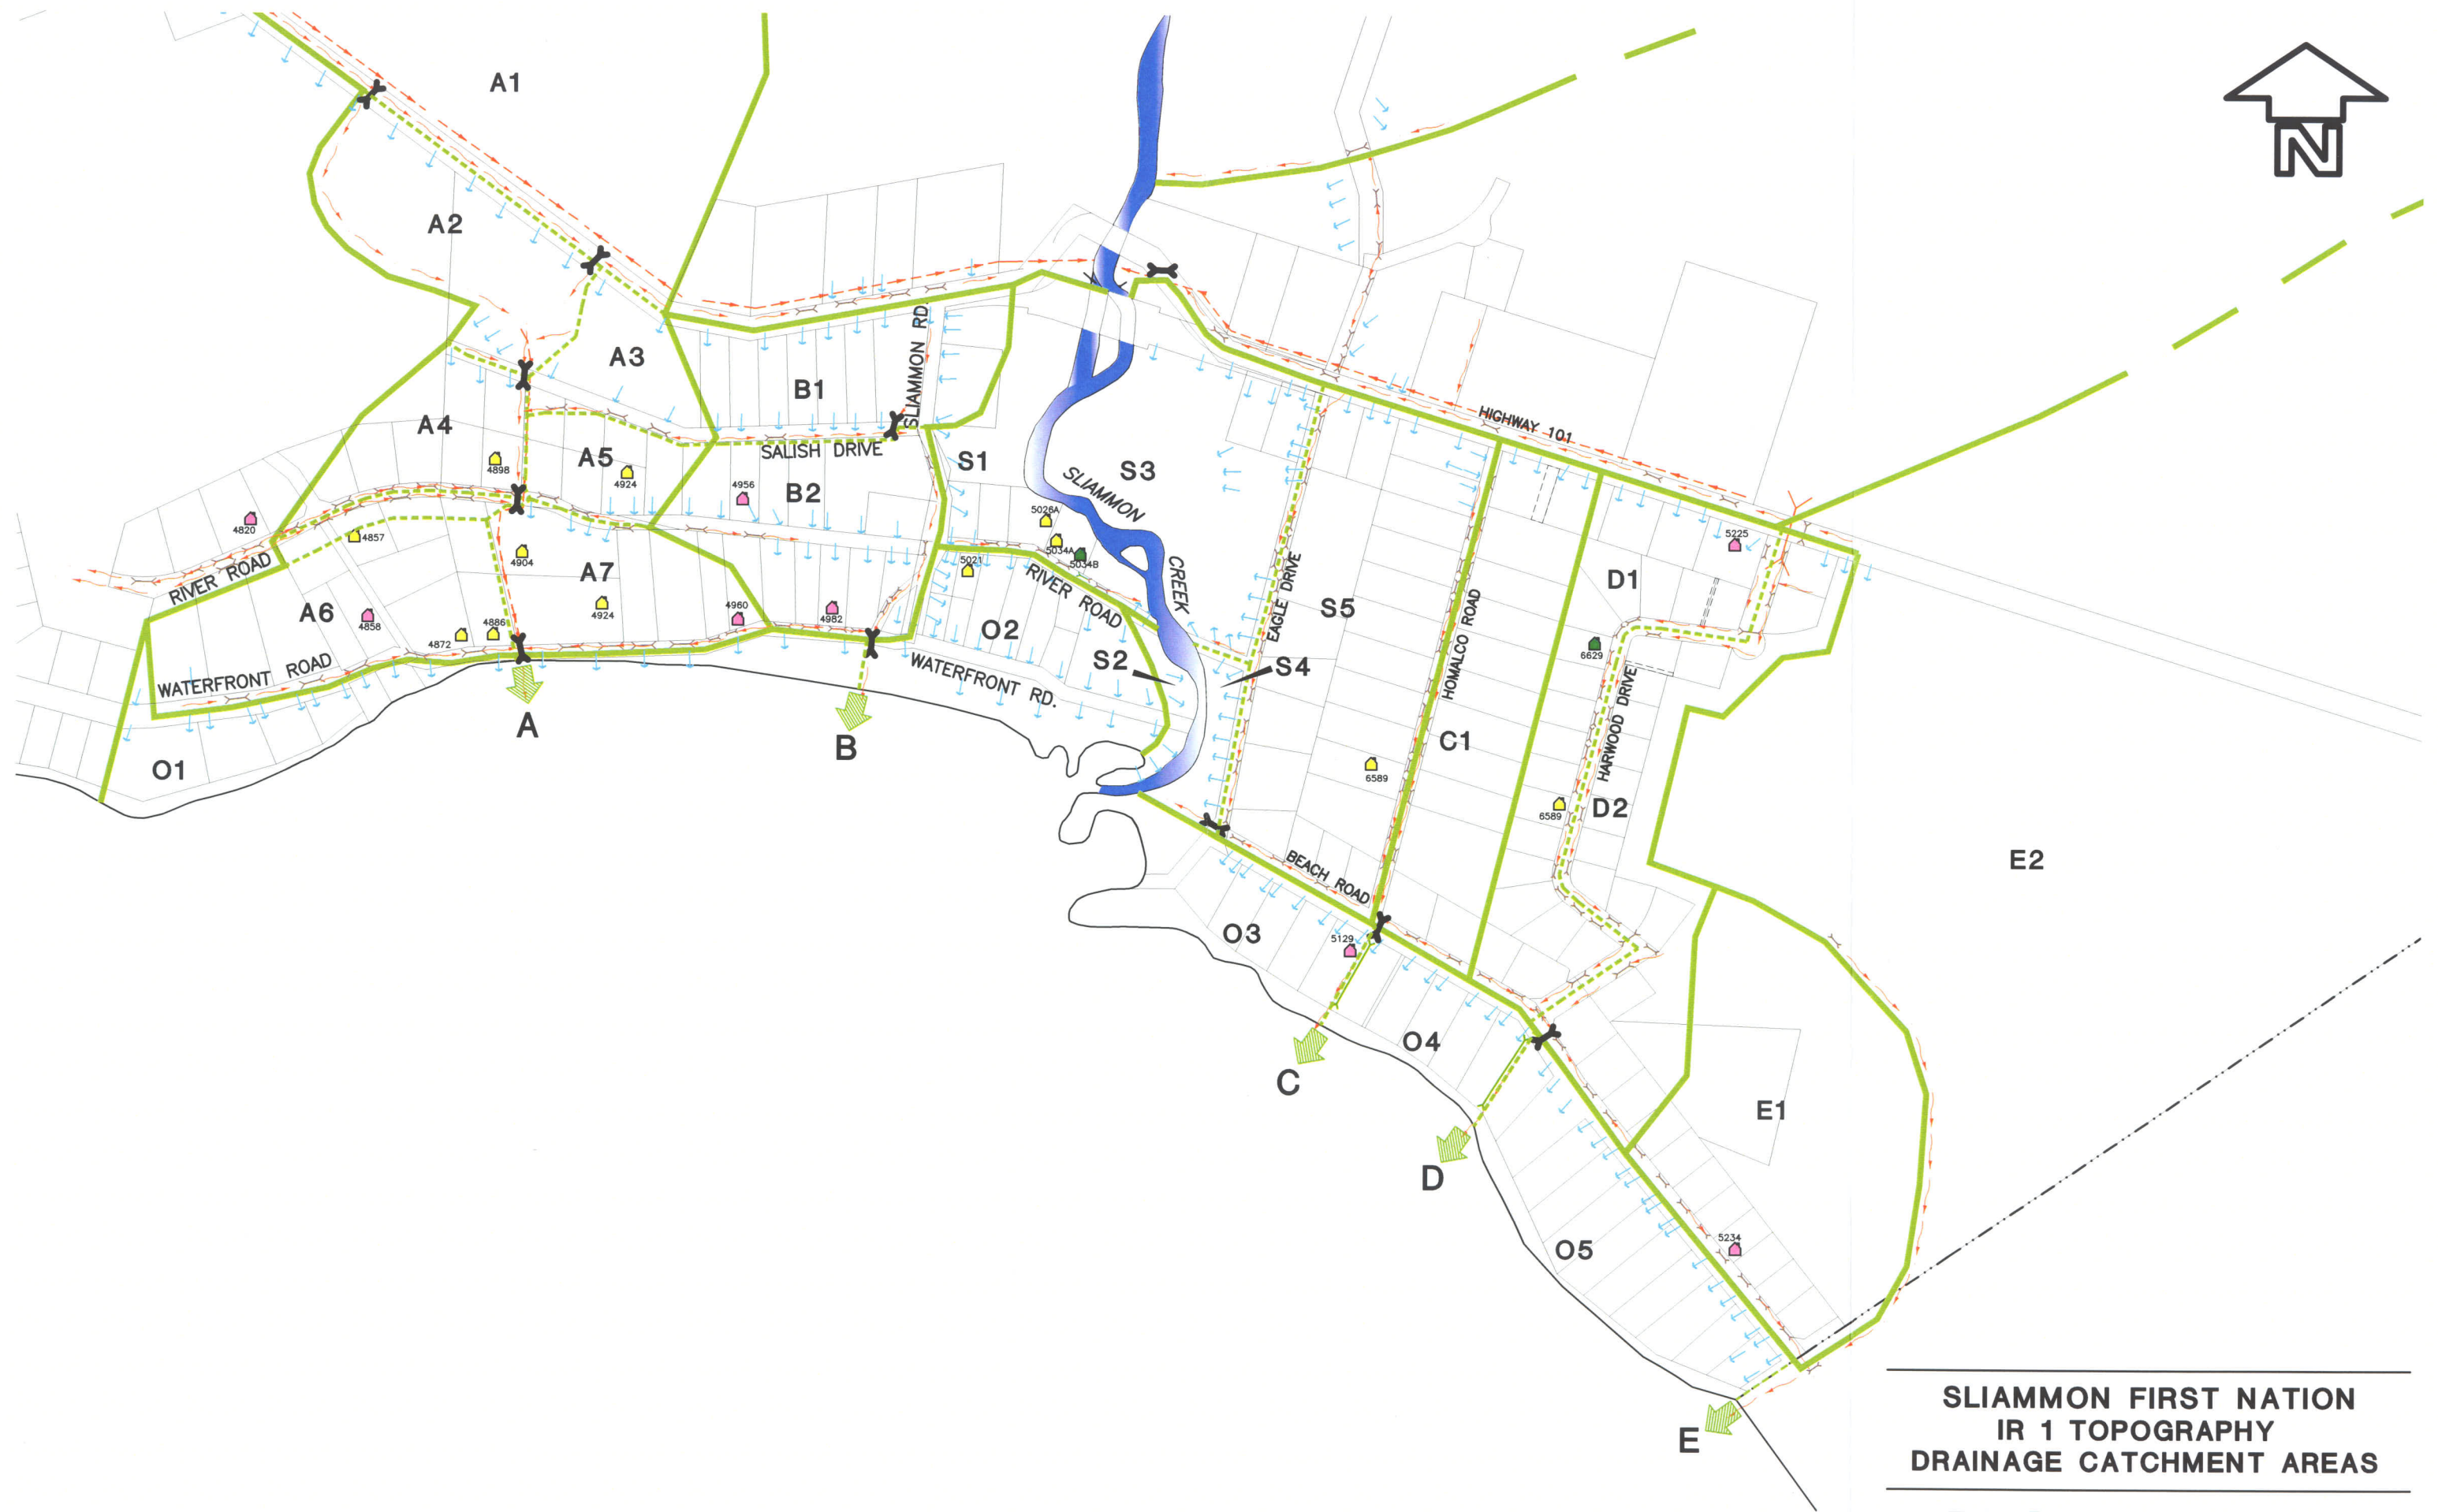
**SLIAMMON FIRST NATION
IR 1 TOPOGRAPHY
DRAINAGE CATCHMENT AREAS**

The existing drainage characteristics of the sub-catchment areas in Sliammon community are summarized in the following table and figure.

The Sliammon Community is located on land, which generally slopes down towards the ocean, with Sliammon Creek flowing through the centre of the community. The overall drainage regime of the catchment area directs surface water either into Sliammon Creek or along man made features to the ocean (Refer to Appendix 1- Figure 1.1).
