Sliammon Creek Hydroelectric Project  
Powell River, BC

Technical Report

**Initial Geotechnical and Dam Assessment**

April 21, 2016

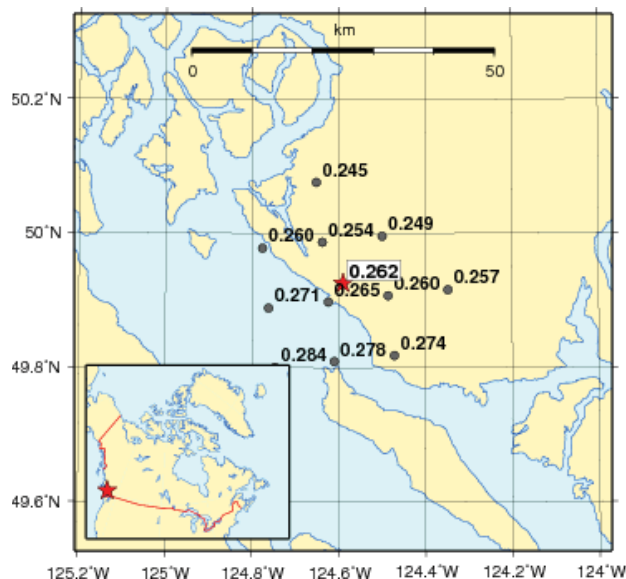
The Sliammon Creek Hydro Project is located on the North American Plate, and about 230 km east of the Cascadia subduction zone that marks the boundary with the adjacent Juan de Fuca plate. Relatively large earthquakes may affect the project area; all project components shall be designed to meet CDA and NBCC requirements. Based on Natural Resources Canada and 2015 National Building Code of Canada, the 2% in 50 year seismic spectral acceleration (S(0.2)) in this area is about 0.566 of gravity and according to Peak Ground Acceleration (PGA) of 0.262g as shown in Table 1 and Figure 5.

Figure 5 – Peak Ground Acceleration (PGA) for 2% in 50 years in the Sliammon Creek dam location

Project structures should be designed to resist the site specific design earthquake events. This typically is the 1:2500 year event for the dam, which is classified as high hazard dam. The potential for liquefaction of foundations of major structures like the proposed powerhouse shall be considered.
